# Repairing TAGH Scintillator Counters Report

July 31, 2019

Wolfgang J. Irrig

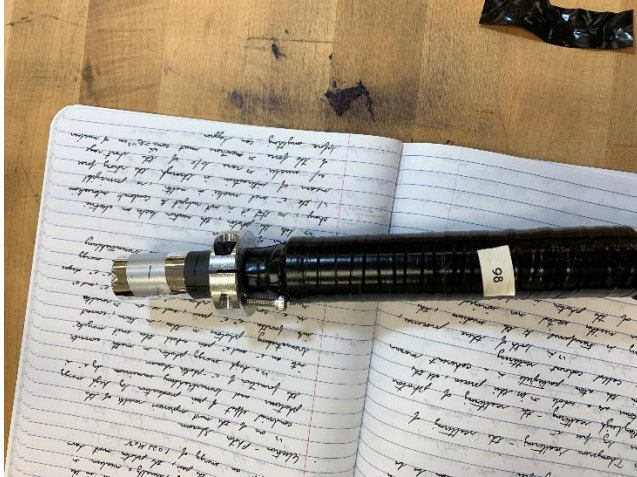
The counters were completely wrapped in black electrical tape (Figure 1). The electrical tape above the joint coupling the light-guide to the PMT was removed along with the mylar and tedlar covering the scintillator and the top part of the light-guide (Figure 2). In every case, the scintillator was either loose enough that it easily came out of the light-guide, was only held in place with the electrical tape covering or was broken with its base still held fast by the epoxy and the upper part completely split from the base (Figure 3). Scintillators were handled while wearing gloves. Scintillator removed from the counter and the counters were placed on a soft white cloth. The scintillator was kept with its counter and its position on the white cloth was numbered corresponding to its counter number (Figure 1).

Figure 2. Counter 98 with its electrical tape above the collar removed as well as most of its tedlar.

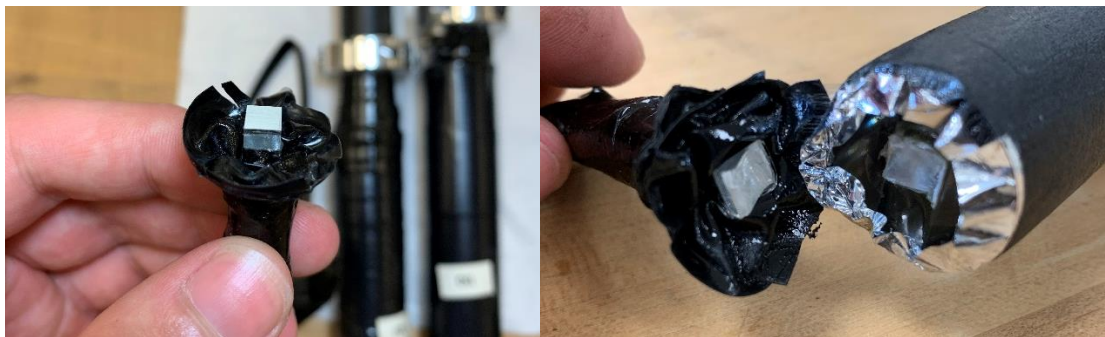
Figure 3. The picture on the write shows how the scintillator, from counter 98, just came right out of most of the counters with just a small amount of force. Also note, there is a white film on the scintillator in the left picture. The picture on the right shows a scintillator that was found to have been split into two pieces.

Scintillators were examined initially for any damage. As elluded to above, 2 counter's scintillators were broken into two pieces – one piece still in the slotted light-guide and the other still in the wrapping (Figure 3). Two scintillators were found to have a pronounced bend (Figure 5). All scintillators were found to have a white film over the bottom part where they rested on the light-guide, as seen in the left picture in Figure 3. This white film severely hindered light from passing through, as it was hardly transparent. Several scintillators had light scratches on towards their bases parallel to the edge of the slot of the light guide (Figure 6).

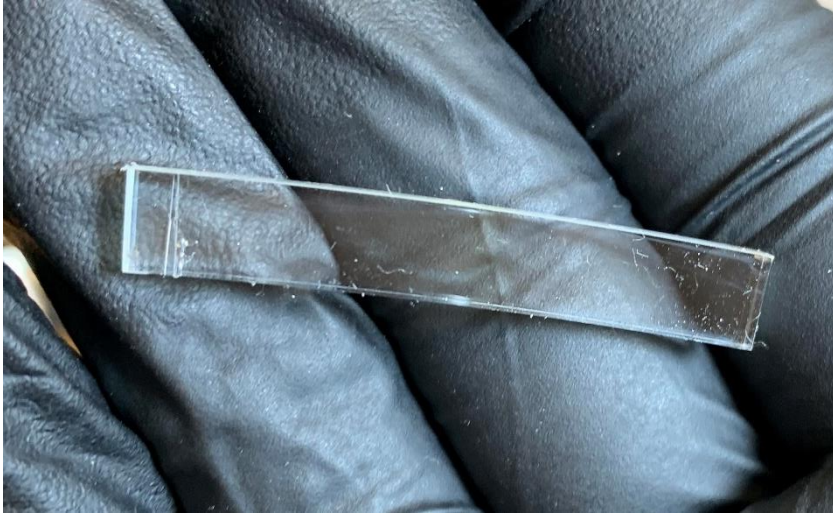
*Figure 5.* This scintillator was found to have a bend to it and was replaced with a straight one.

The following lists broken or defective parts and remedies to these problems: Bent scintillators were replaced with straight edged ones. The issue of the air bubble between the PMT and light-

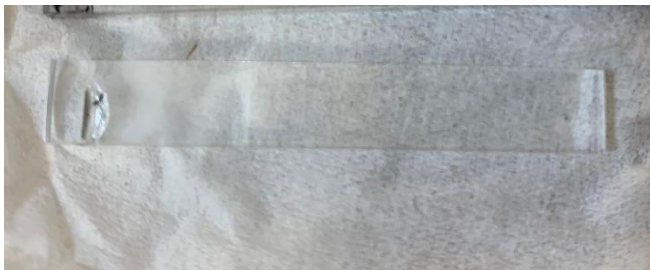
*Figure 6.* Towards the left part of the scintillator is a chip missing where it would have rested against the edge of the slot of the light-guide.

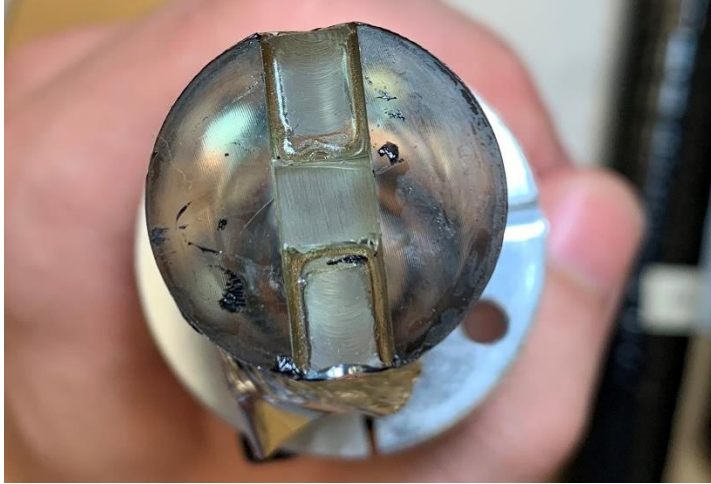
Light-Guides were also checked for damage, such as scratches, and to see if there were any air bubbles between the PMT and the light-guide, and on cloudiness. Light-Guides had epoxy in their slots where they had held the scintillators fast (Figure 7). As in figure 7, some light-guides had residue of adhesive from direct contact with black electrical tape. One light-guide was noticeably cloudy, even after polishing and another had a large air bubble between the PMT and light-guide (Figure 8).

*Figure 7.* View of counter 98's light-guide. The indentation in the epoxy is where the scintillator once rested. Also note the black-electrical tape adhesive found on the light-guide.

After the epoxy was removed, isopropanol was lightly applied to the soft side of the cloth and then rubbed onto the light-guides. This removed bits of epoxy and any adhesive that was on the light-guides from electrical tape directly touching them (Figure 7). Then Novus Heavy Scratch and Fine Scratch Remover were used on the light-guides. Like the scintillators, the heavy scratch remover was applied to the soft side of the cloth and rubbed in the slot of the light-guide on any scratches or thin layers of leftover epoxy. This was repeated 5 times. Then the fine scratch remover was rubbed in the same fashion at least 5 times, until a clear visual of the top of the PMT was achieved looking down through the light-guide (Figure 13). Isopropanol was then applied to a cloth again and used to clean off any remaining dried polish. Leftover cloth fibers were wiped away with gloves.

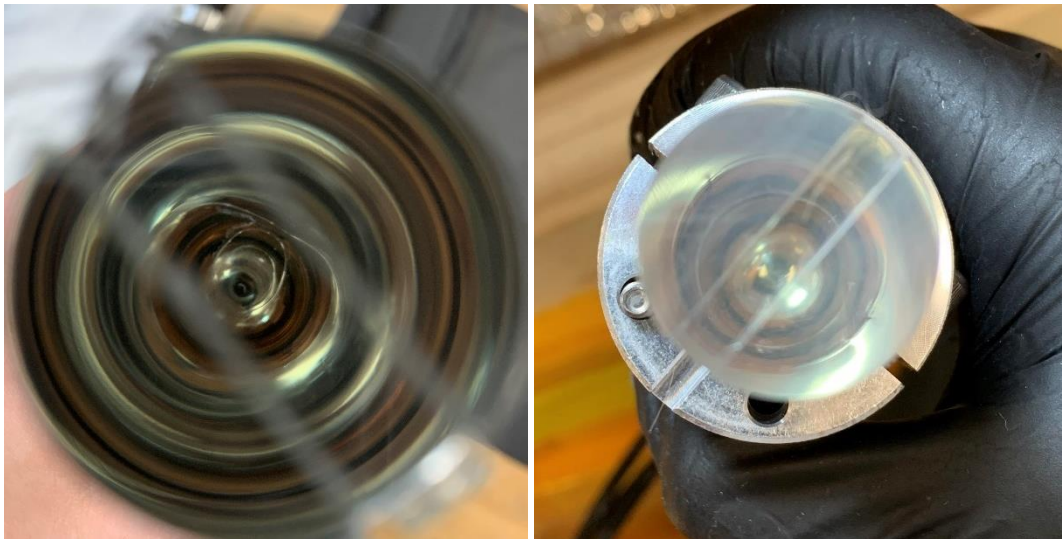
*Figure 8.* The left picture was shot looking through the light-guide towards the PMT. There is a clear air bubble between the two. The right picture shows a murky light-guide, counter 170.

guide was remedied through replacing the light-guide and PMT with a similar sized one without an air bubble. An electrical engineer soldered the wires back to the circuit board in all three cases where the wire had been reattached.

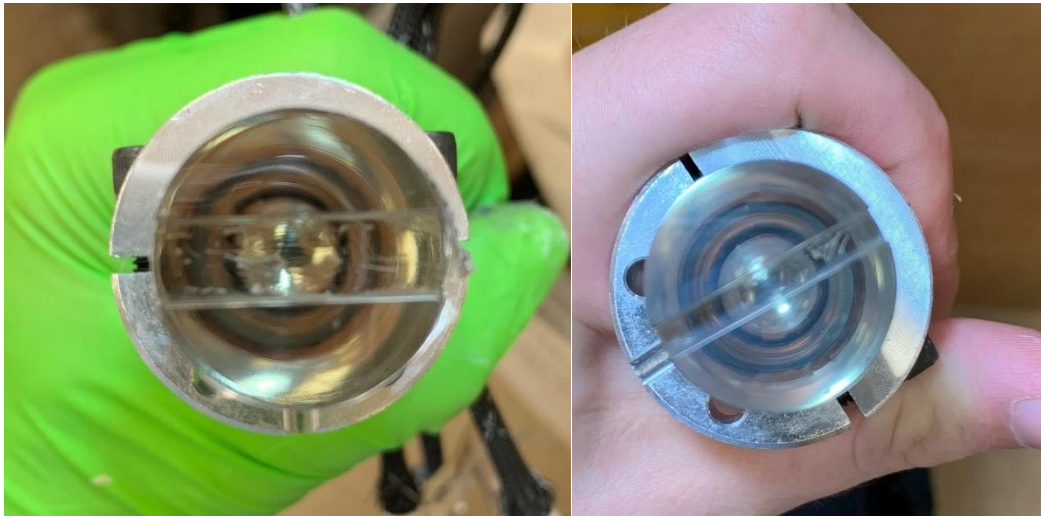
*Figure 12.* Comparison between scratches left by exacto knife, left picture, and poking tool for removing epoxy from the light-guides, right picture. Both have been polished.

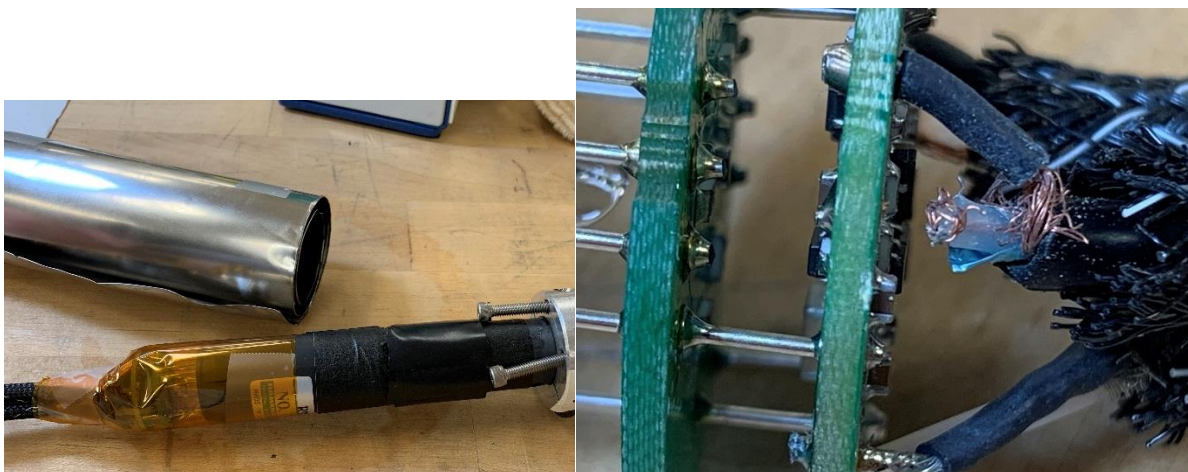
Unsuccessful counters have their bottom ends unwrapped and mu-metal shields and keplar wrap removed so that the wires can be examined. In all three cases where channels were not functional, wires were detached from the circuit board, as seen in figure 18.

Figure 18. The left picture shows the exposed PMT with keplar wrapped around it still and the mu-metal shielding removed. The right picture shows a wire disconnected from the circuit board, counter 125.

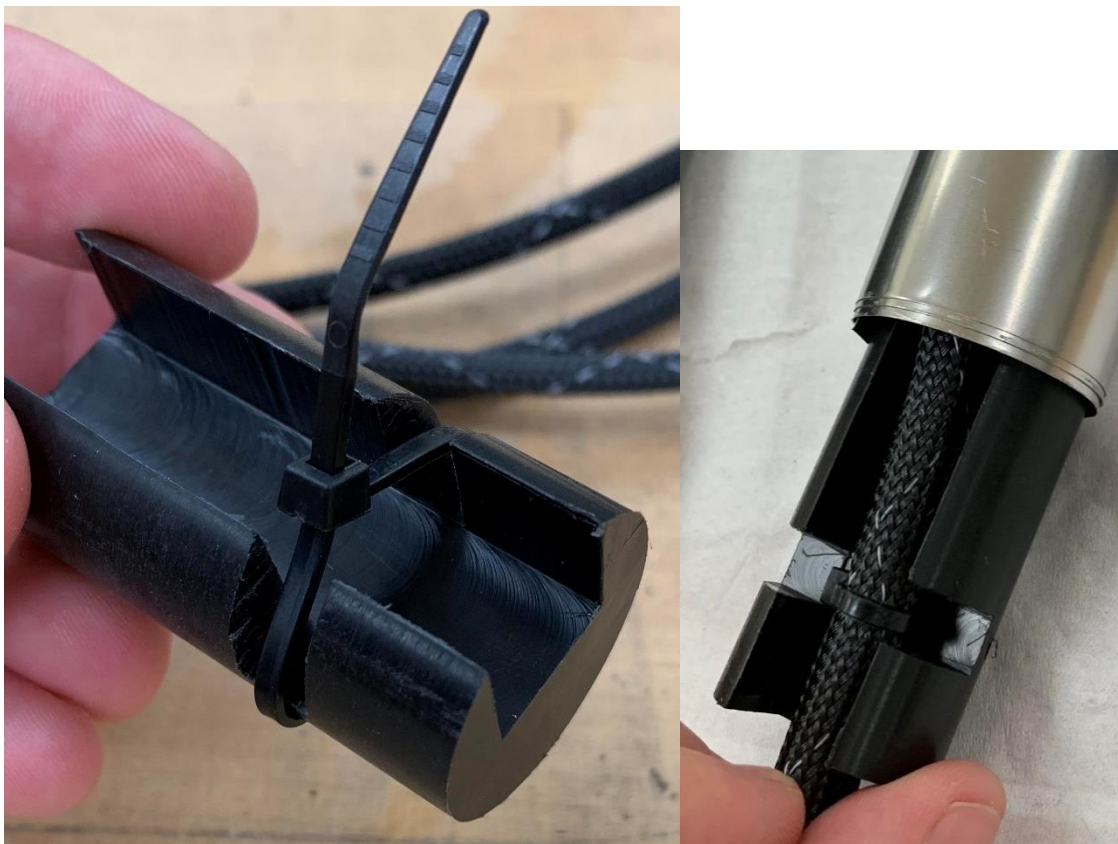
*Figure 19.* The plastic insert was built to ensure future wires would not become disconnected from the circuit board. The right picture shows how it is inserted into the mu-metal shielding of the PMT.

To ensure further wires would not be pulled off their circuit boards, Joshua Krafts devised a novel way of securing them to the mu-metal housing. He took a plastic dowel and machined it into what is depicted in figure 19. This machined piece of plastic was placed an inch inside the mu-metal and the outer part taped with black masking tape to hold and keep the part from coming loose. Then the wires were held fast to the part through use of a zip-tie. This was all then wrapped in electrical tape to about an inch below where the wires came out of the machined part. This transferred the stress of tugging wires from the soldered joints on the circuit board to the mu-metal housing.
