Mini-BCAL Bench testing

Tara Bogart, CNU

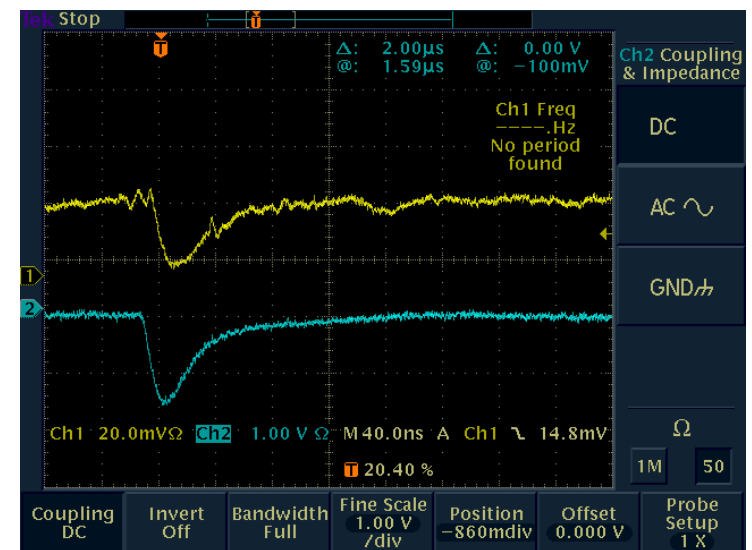
Cross-talk

Some cross-talk was observed between channels when LED was flashing

Unclear whether due to light or electronics

Will investigate further once gain-matched voltages can be applied

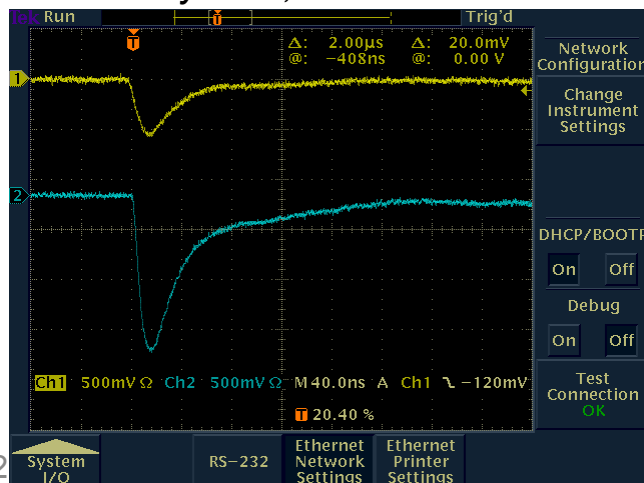
Layer 10, Sector 2

LED signals read from both ends

- LED flashing Downstream end only
- SiPM biases both set to 75V
- Read out 1 SiPM at a time
- Upstream to downstream amplitude ratio is $\sim 3:1$ (without gain matching)

All channels check out OK!

*Yellow (top) = Downstream
Blue (bottom) = Upstream*
