# USM Update

## 13/01/2011

# Electronic Front-End for MPPC Test Facility

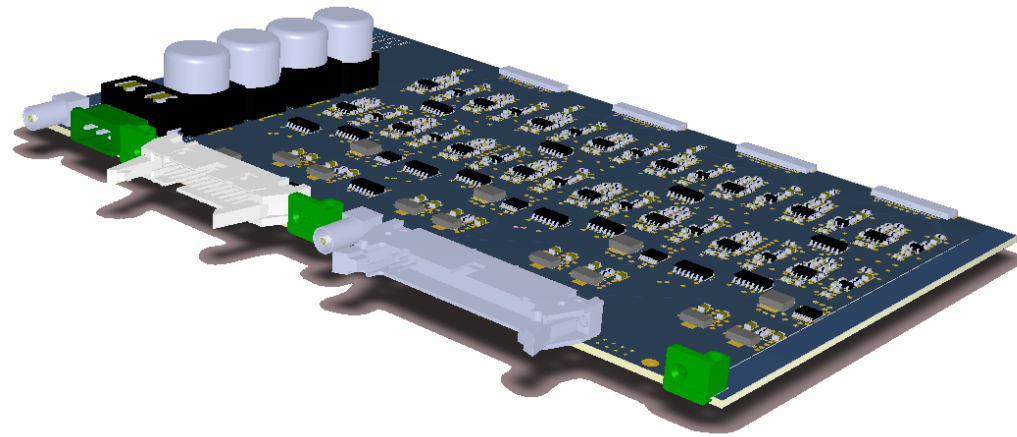
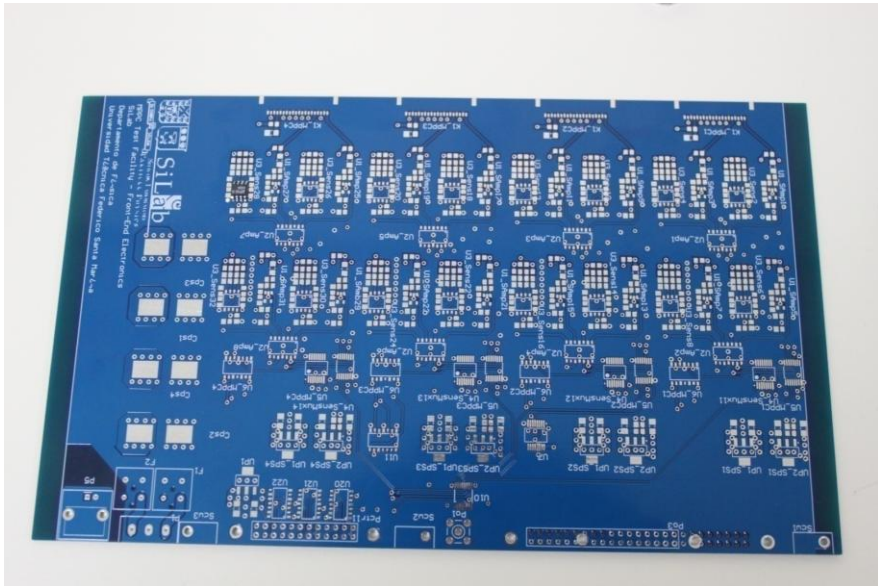
- Some problems were found in the first prototype
  - Traces to amplifier were poorly routed
  - Flat cable connector was inadequate, so we returned to using a Card Edge Connector

- A more modular approach has now been adopted:
  - The design of the current sensing board and the amplifier board will be retained, however,
  - They will now be configured as two daughter boards attached to the main board

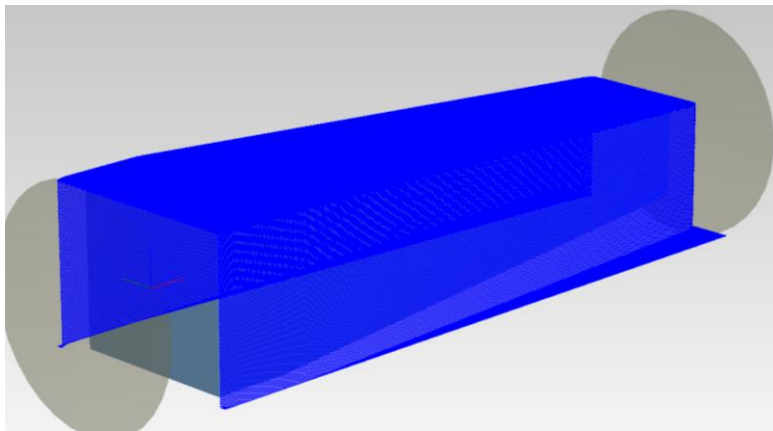
Picture 1.

- Long time milling (33 hours).
- Lower surface quality.

- Basic CAM Software had limited features .
- Finishing process removed material by using both the bottom and **sides** of the cutter (bit).

33 hours per LG  
Low quality  
1 LG at a time

8 hours per LG  
Better quality  
2 LG at the same time

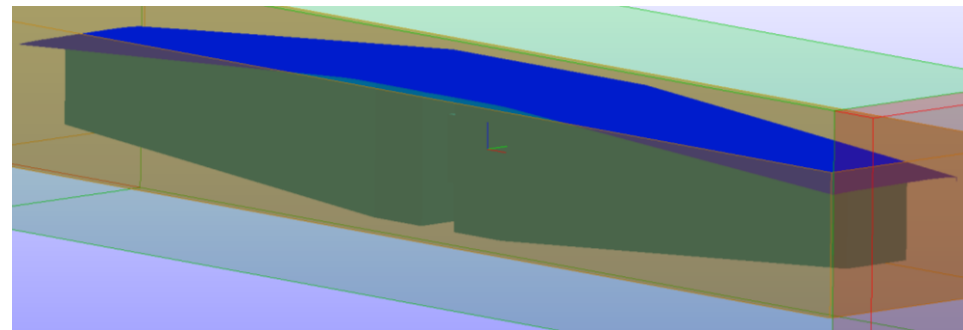
Picture 2 : Machining two at the same time in an 16 hour process.

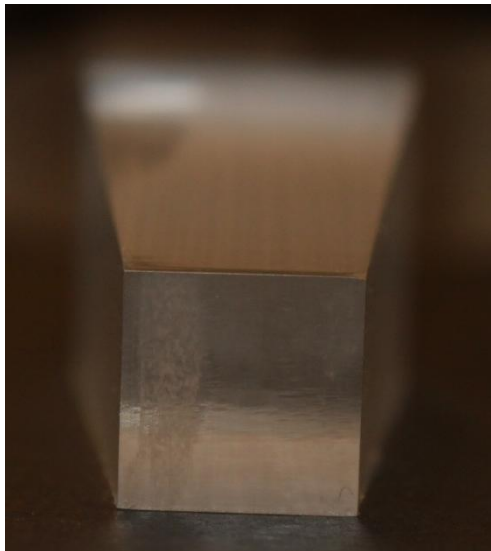
Picture 5: Top Surface.

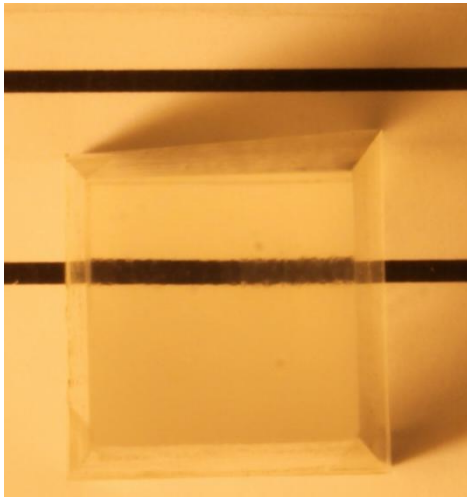
Picture 7: View through Top and Bottom Surface. After fifth milling process.

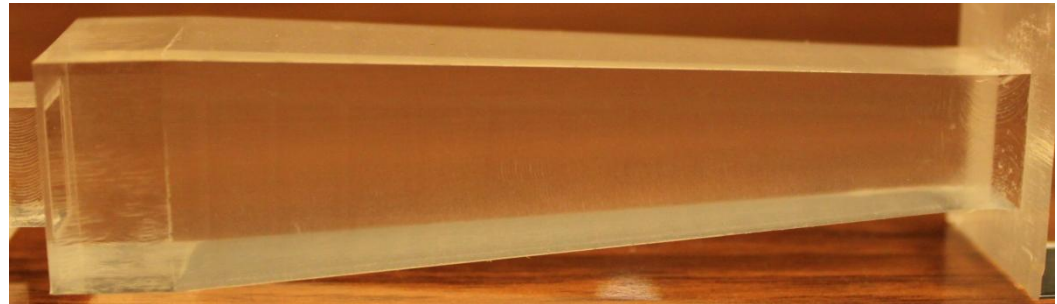
Picture 8 :After second milling process.

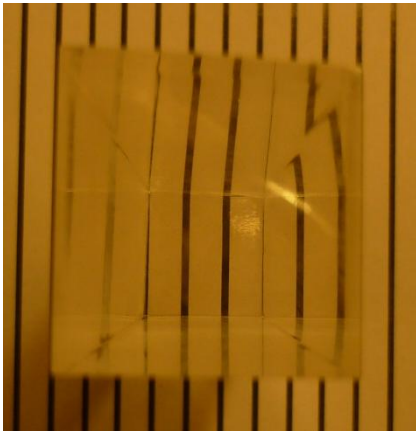
Picture 9: View through Bottom and Top Surface.

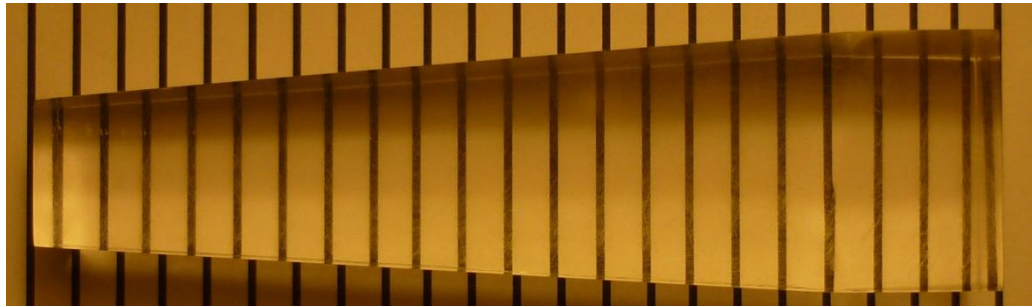
Picture 10: View through both sides surface.
