# Repairing TAGH Scintillator Counters Report

July 31, 2019

Wolfgang J. Irrig

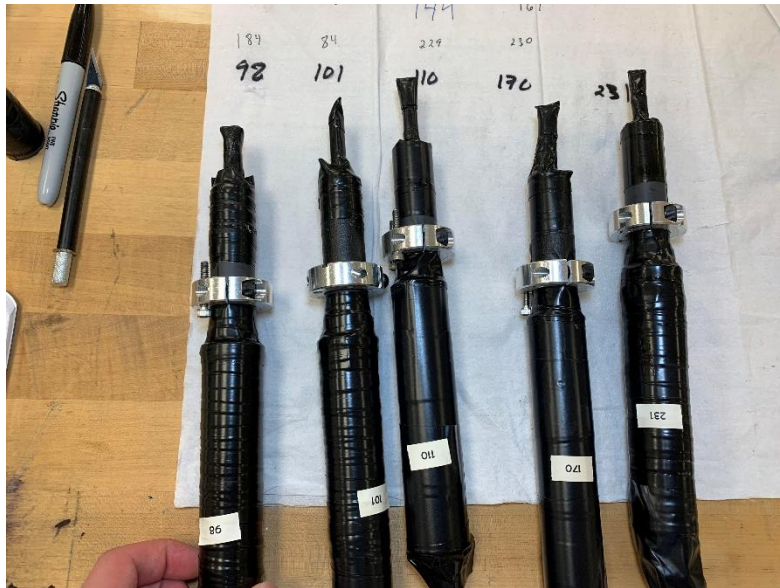
The counters were completely wrapped in black electrical tape (Figure 1). The electrical tape above the joint coupling the light-guide to the PMT was removed along with the mylar and tedlar covering the scintillator and the top part of the light-guide (Figure 2). In every case, the scintillator was either loose enough that it easily came out of the light-guide, was only held in place with the electrical tape covering or was broken with its base still held fast by the epoxy and the upper part completely split from the base (Figure 3). Scintillators were handled while wearing gloves. Scintillator removed from the counter and the counters were placed on a soft white cloth. The scintillator was kept with its counter and its position on the white cloth was numbered corresponding to its counter number (Figure 1).

*Figure 1.* Initial state of the scintillator counters before any work was done to them.

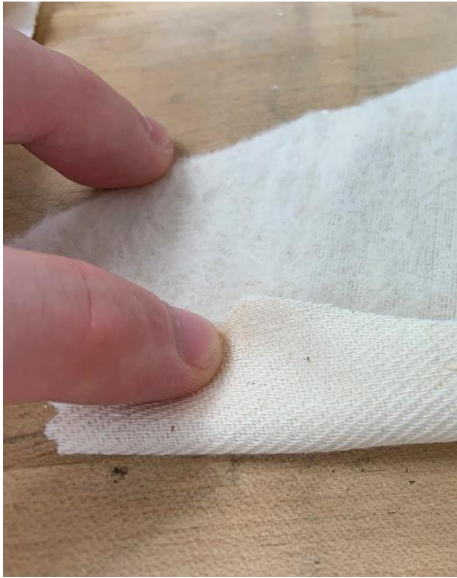
*Figure 9.* This is a picture of the cloth used to polish the light-guides and scintillators. The soft side was used for rubbing against the surfaces with the polish.

Scintillators were all polished to remove the white film on the ends connected to the light-guides. Novus Heavy Scratch Remover and Fine Scratch Remover was used as the polish. A cloth that was soft on one side and hard on the other was used with the polish (Figure 9). The polish was applied, a small dab, to the soft side of the cloth and the scintillator rubbed in a circular motion in the polish against the cloth. Gloves were worn while this was done. First the heavy scratch remover was used. A small dab of the polish was used, and the scintillator rubbed against the

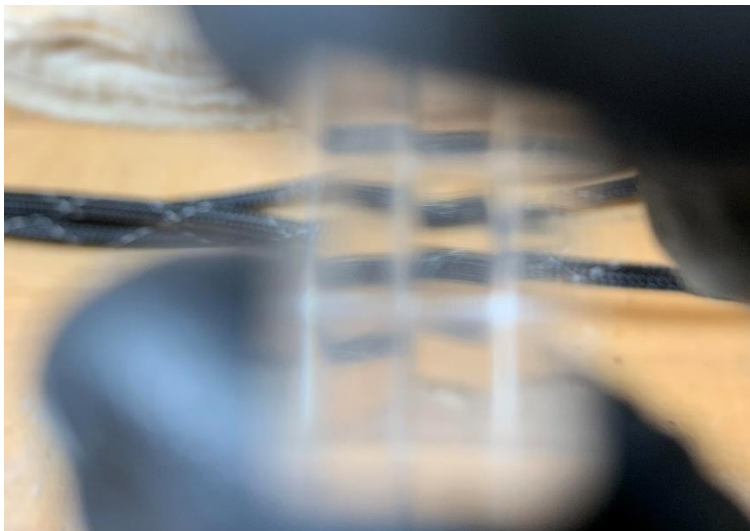
*Figure 10.* Picture looking through polished scintillator.

polish and cloth until polish was dry. This was repeated three or more times. Then the same was done with the fine scratch remover. Once the scintillator has the white film removed and can be seen through longitudinally relatively clearly, any fibers from the cloth were removed with gloves (Figure 10).

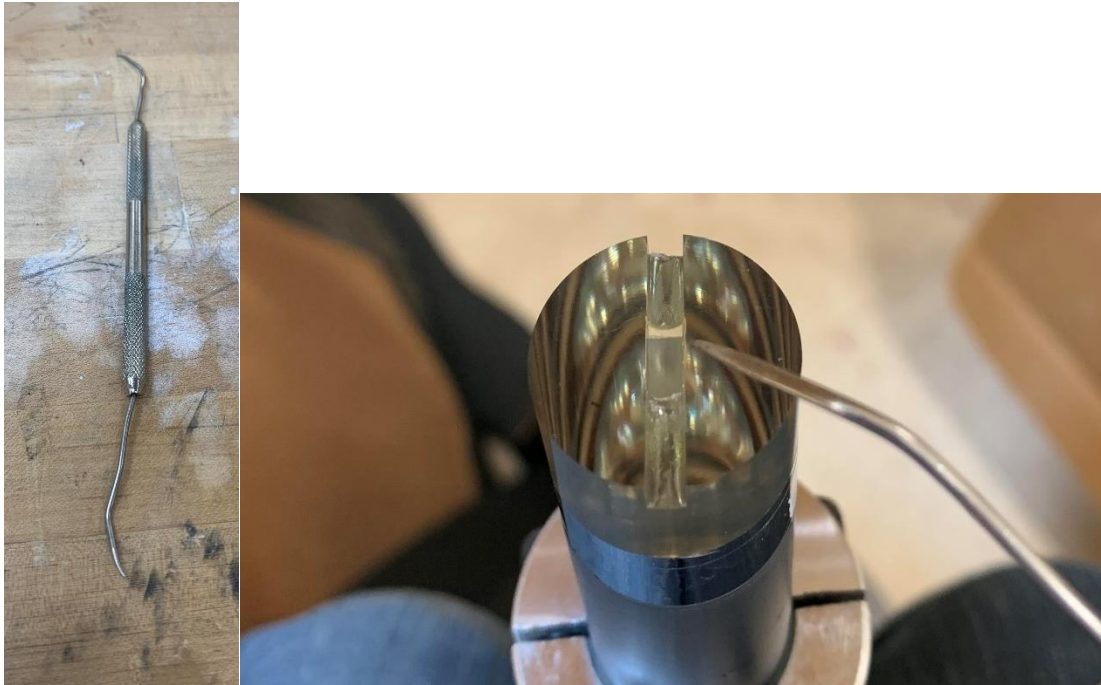
*Figure 11.* Poking tool used to remove heated epoxy.

light-guide. The heat gun was held nearly perpendicular to the light-guide's longitudinal axis, aimed at the epoxy. After 7-10 seconds, the light-guide was rotated 180 degrees while under the heat gun. A poking/ prodding tool was used to delicately lift off the heated epoxy (Figure 11). An exacto-knife was originally used but resulted in too many scratches to the light-guides, so was no longer used with the later counters. The poking tool also sometimes results in small scratches to the light-guides but caused less severe scratches than the exacto-knife (Figure 12).

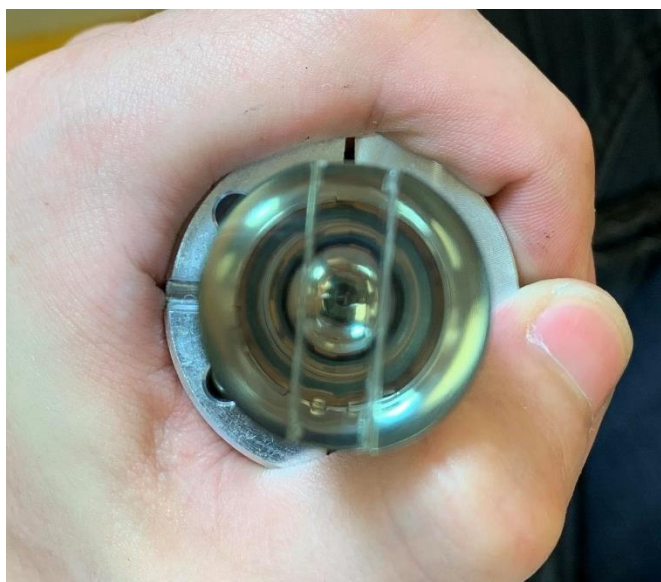
*Figure 13.* Light-guides were polished until the PMT coupled side were as clear as possible.

After the epoxy was removed, isopropanol was lightly applied to the soft side of the cloth and then rubbed onto the light-guides. This removed bits of epoxy and any adhesive that was on the light-guides from electrical tape directly touching them (Figure 7). Then Novus Heavy Scratch and Fine Scratch Remover were used on the light-guides. Like the scintillators, the heavy scratch remover was applied to the soft side of the cloth and rubbed in the slot of the light-guide on any scratches or thin layers of leftover epoxy. This was repeated 5 times. Then the fine scratch remover was rubbed in the same fashion at least 5 times, until a clear visual of the top of the PMT was achieved looking down through the light-guide (Figure 13). Isopropanol was then applied to a cloth again and used to clean off any remaining dried polish. Leftover cloth fibers were wiped away with gloves.

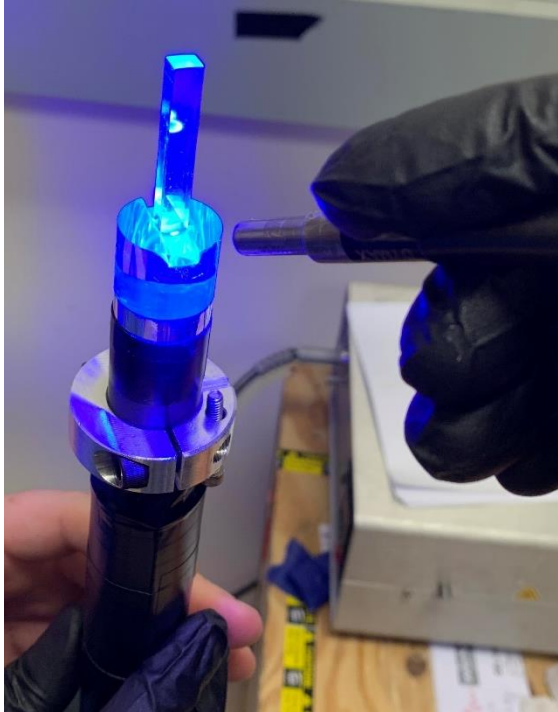
*Figure 14.* Picture showing the UV pen being used on the epoxy that mounts the scintillator to the light-guide securely.

A UV curing epoxy, Ultra Light-Weld Adhesives and Coatings 3094 by Dymax, was used to attach the scintillators to the light-guides along with a UV pen (Figure 14). After the UV pen had warmed up, two people were required, one to hold the counter and the other the hold the UV pen. Safety eye wear were worn to ensure protection from the UV light. A moderate dab of epoxy was placed in the middle of the slot of the light-guide. Then the scintillator was placed in the middle, ensuring that it was straight and directly in the middle of the slot. The UV pen was held at each of the four sides of the scintillator pointed diagonally down towards the epoxy for 15 seconds a side. Then the UV light was shined down the scintillator to ensure the epoxy under the scintillator cured properly, again for 15 seconds. The UV pen was held approximately 1-2 inches away from the epoxy.

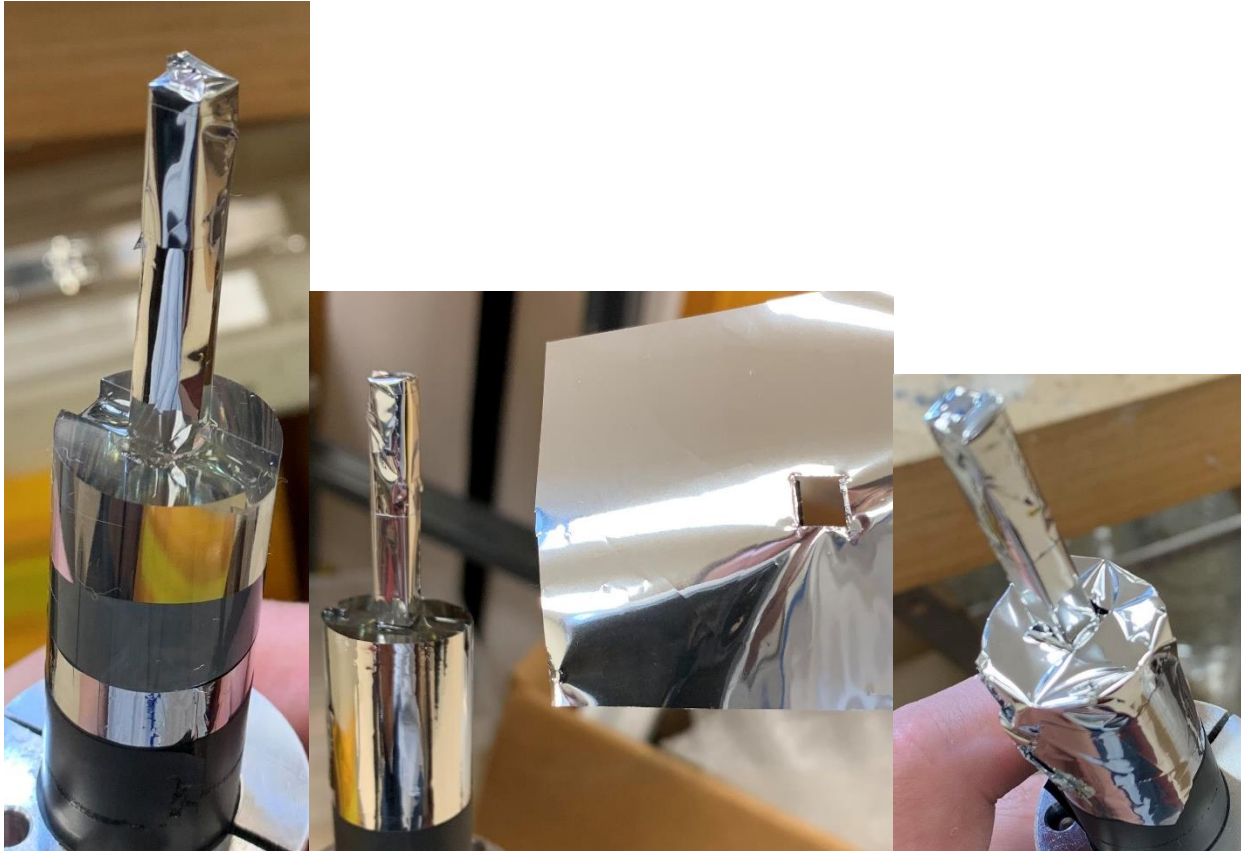
*Figure 15.* This figure shows pictures in order of the processes detailed above. First mylar is wrapped around the scintillator, then cylindrical part of the light-guide, followed by the top part of the light guide. Everything is taped using a mylar tape.

Once the scintillator is glued back into its place an initial layer of mylar, with length slightly larger than the scintillator, is wrapped around the scintillator. A piece of mylar tape is then used to keep the mylar tight against the surface of the scintillator. The extra mylar wrap above the scintillator is folded down and taped. Next a rectangular piece of mylar is used to wrap around the light-guide and taped using the mylar tape. Then a square piece of mylar is cut with a small rectangle the size of the scintillator is cut out of its middle, so that it may slide down over the scintillator and on top of the light-guide. Opposite end of this piece is then tapped down. Next two cuts are made in the other two ends of the now taco shaped piece of mylar and folded around and down the side of the light-guide. This wrap of mylar is essential to reflect the light from the scintillator and keep ambient light outside of it out. Figure 15 shows pictures of this process.

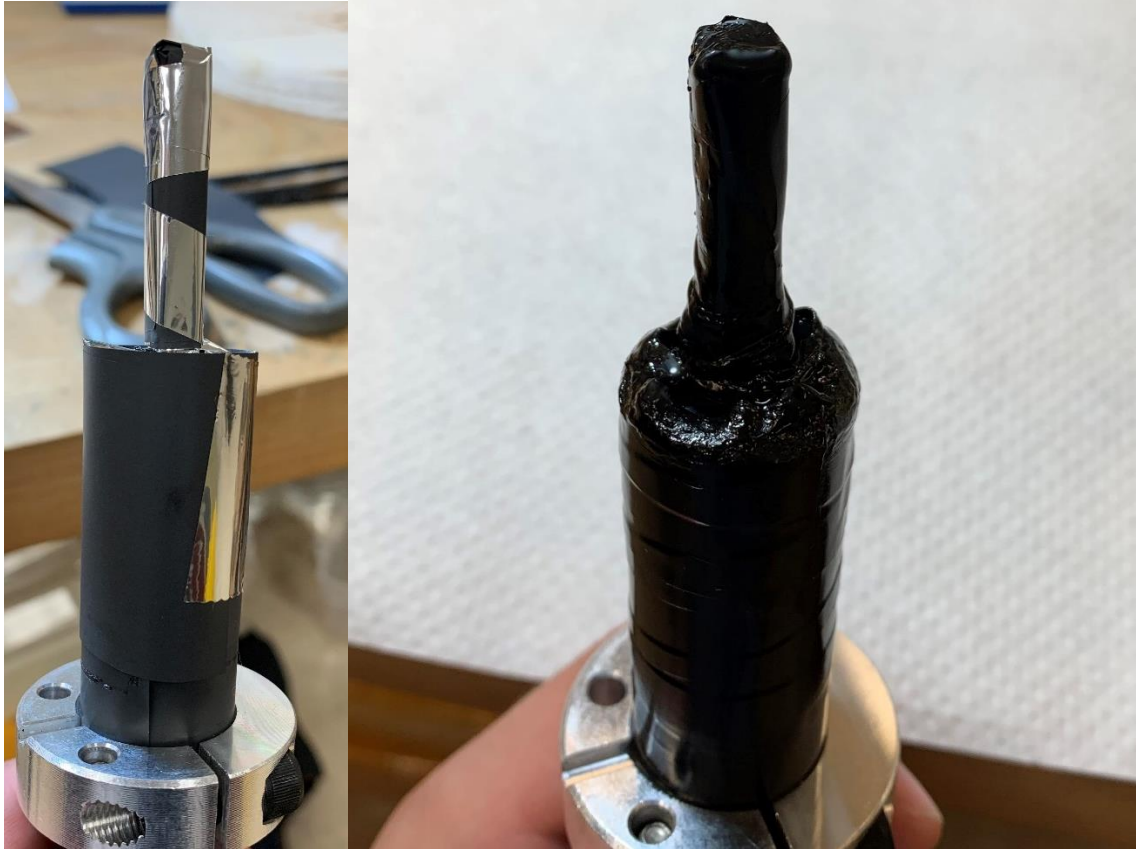
*Figure 16.* The picture to the left shows the tedlar around the scintillator and cylindrical portion of the light-guide. A mylar tape was used on the tedlar. The right picture shows the black electrical tape wrap starting at the joint and extending up to the base of the scintillator. The scintillator and top of portion of the light-guide were then covered in liquid black electrical tape.

Tedlar is then wrapped around the scintillator and light-guide in the same way the mylar was; no tedlar piece is inserted over the scintillator to rest on the top of the light guide though. Next electrical tape starting at the base of the light-guide and spiraling up just above the base of the scintillator is employed. Then liquid electrical tape is placed on the tedlar of the scintillator and on top of the electrical tape on top of the light-guide. This ensures light does not leak into or out of the top side of the counter. Figure 16 shows pictures of this process.

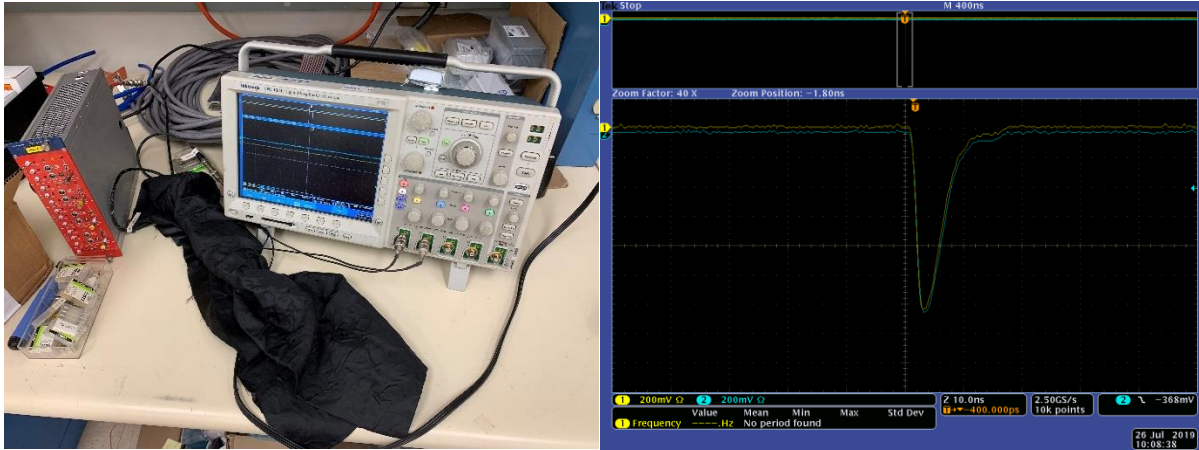
The test set up for the counters is as follows: a Tektronix DPO 4034 Digital Phosphor Oscilloscope and a C.A.E.N. power supply delivering 900 volts are connected to the counter. The counter is further wrapped in a black plastic sheet while being tested. The counter is checked to see if it can detect cosmic rays in both of its channels, which is displayed on the oscilloscope as a large signal voltage relative to background noise. The trigger was set to look at large signals above several 100mV, these were thought to be cosmic rays. Figure 17 shows both the setup for the tests and an example of a positive test for detecting cosmic rays.

Figure 17. Picture on the left shows the set-up with the counter wrapped in the black tarp connected to the power supply on the far left and the oscilloscope on the right. The right-hand picture is from the oscilloscope – these were the type of readings that positively identified that both channels of the counter were working.
