# Start Counter

- Experimental Setup
- SiPM Scan
- Attenuation Lengths
- Time Resolution Studies
- Future Plans

# EJ-212 Scintillator Bar

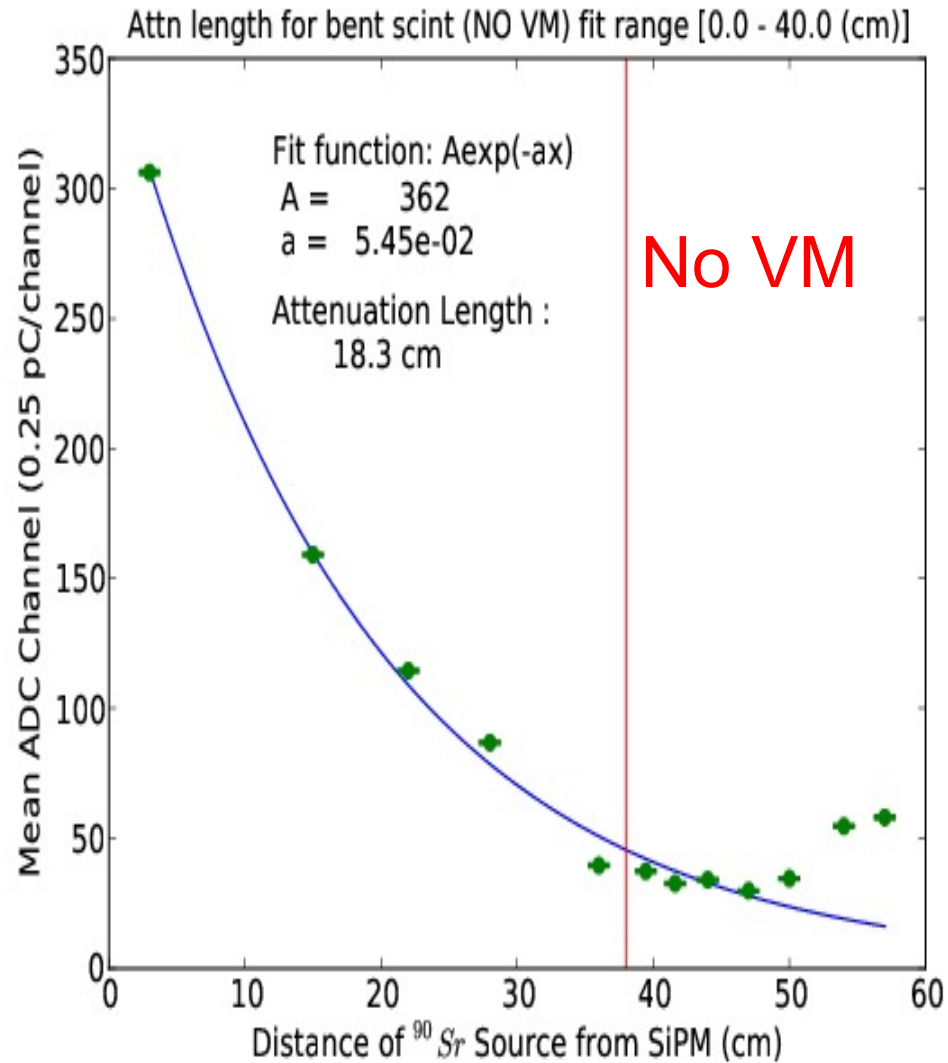
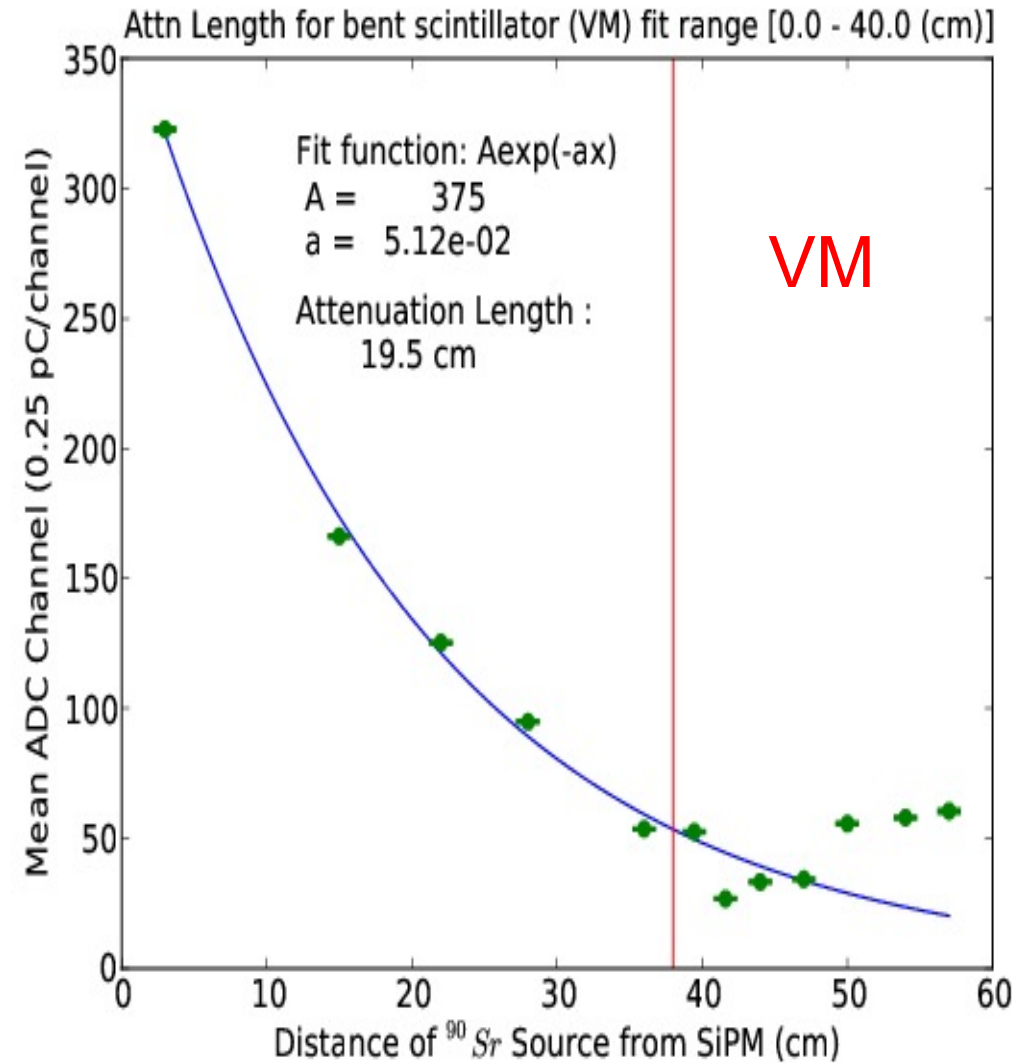
# Attenuation Length Plot for Scintillator 1 (Typical Response)

- VM2000 has **no significant effect**
- Fit Range (0.0 - 40.0 cm)

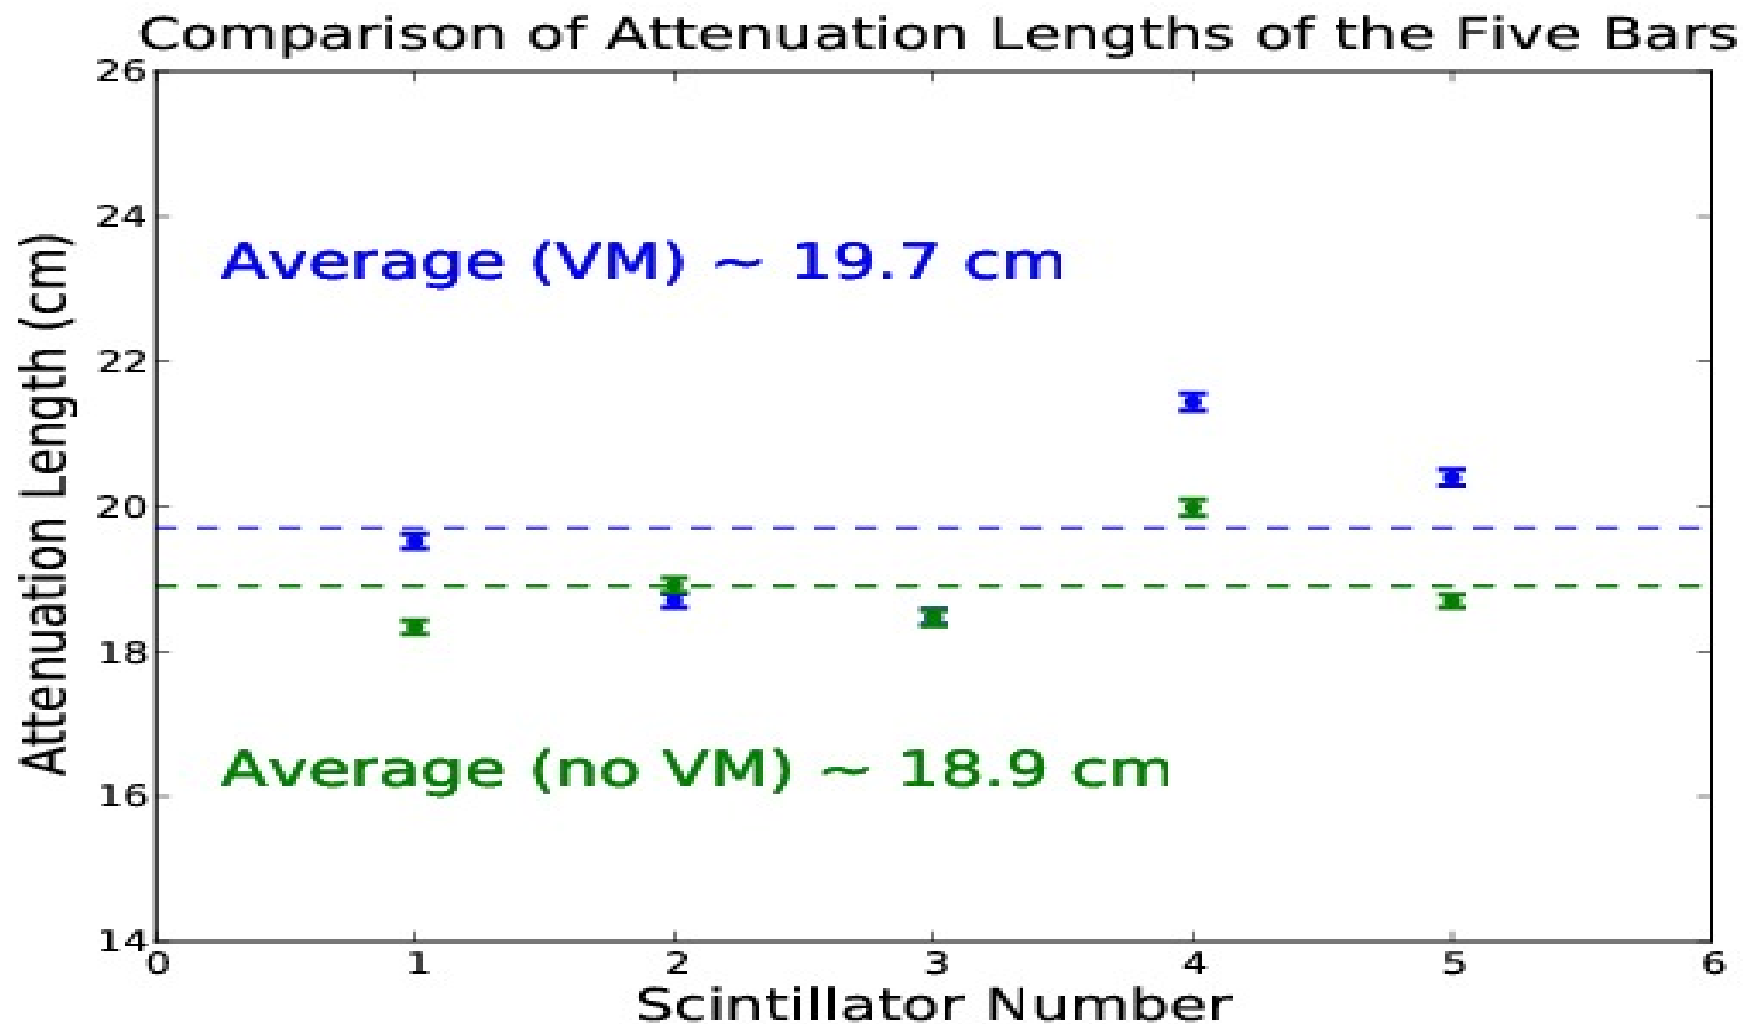
# Average Attenuation Lengths

- The attenuation lengths of all five scintillators are approximately the **same**

Scintillator Number	No VM2000 (cm)	With VM2000 (cm)
1 (best)	18.3	19.5
2	18.9	18.7
3	18.5	18.5
4	20.0	21.4
5 (worst)	18.7	20.4
Unbent Scintillator	70.6	129.0

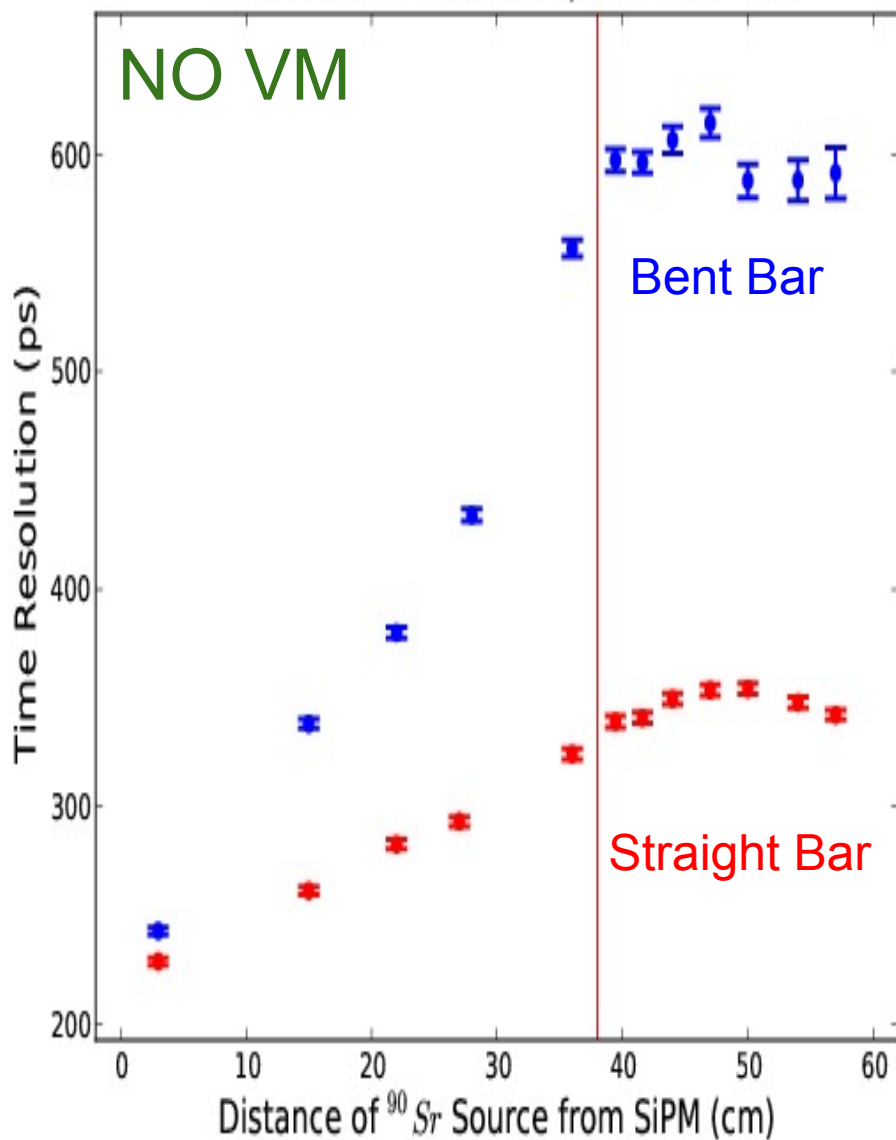
Time Resolution Plot Comparison (No VM)

- Coupling of scintillator to "sweet spot" of SiPM
- We measured the time resolution as a function of distance of source from SiPM
- Comparative measurement with straight scintillator
  - Both with and without VM2000
- Comparative time resolution measurements with FM-PMT, Old SiPM, and New SiPM

- Without VM2000
  - Time resolution is relatively **constant** in nose
- With VM2000 at tip of the nose
  - Time resolution **improves** as a function of increasing distance
- Worst time resolution occurs in the bent region  
Same as light output
- Time resolution measurements were **relatively consistent** among all of the scintillators
- Overall we find:  **$230 \text{ ps} < \sigma < 640 \text{ ps}$**  for the bent scintillators
- New Pre-Amp **improved** the **time resolution** as expected

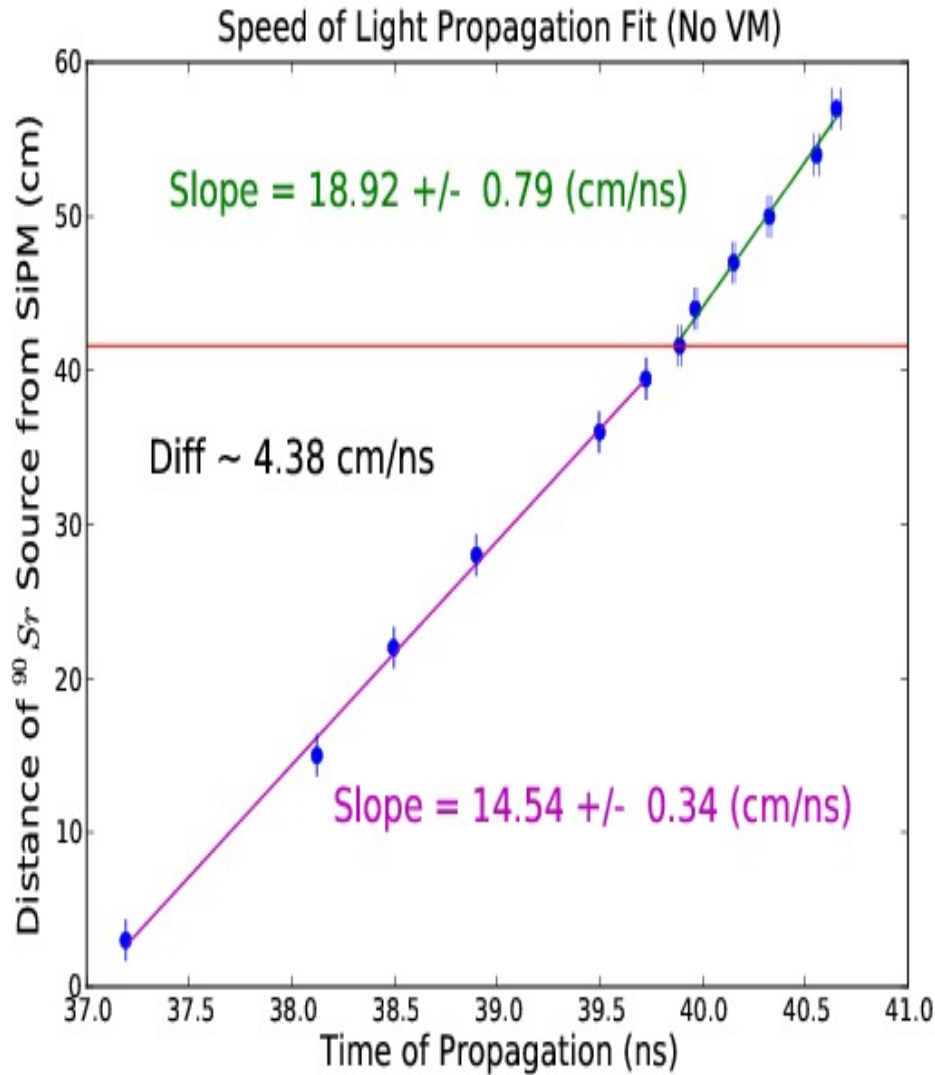
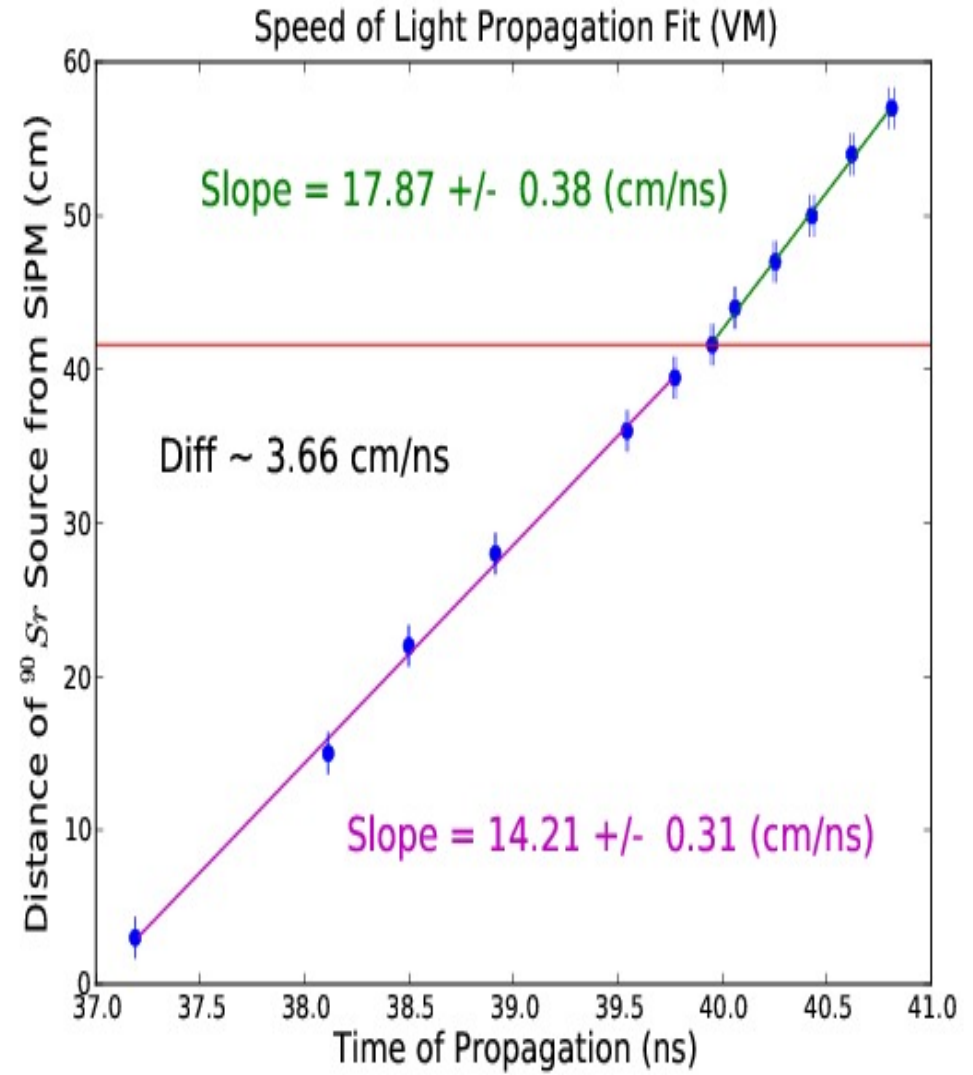
# Propagation Studies (Scintillator 4)

- We measured the speed of light within the five scintillators
  - With and without VM2000
- Fit **two** separate linear functions
  - Straight Section
  - Bent Section

- **Similar** traits were noticed among the five scintillators

- Linear relationship was found between the time of propagation and the distance from the SiPM (as expected)
- There exists a **difference** in the fitted slopes when comparing the nose and the straight section
- On **average** the propagation speeds differed in the **nose** when compared to the **straight** section as:
  - Without VM2000
    - 4.61 cm/ns faster
  - With VM2000
    - 6.23 cm/ns faster
- Due to the change in **geometry** of the scintillator after the bend
  - Fewer number of reflections in nose
